**ECOLOGICAL PROBLEMS OF RESTORATED TRADITIONAL  
SETTLEMENTS: A CASE STUDY IN KALEİÇİ (ANTALYA)**

*R. Eser GÜLTEKİN\**  
*Hacer MUTLU DANACI\*\**

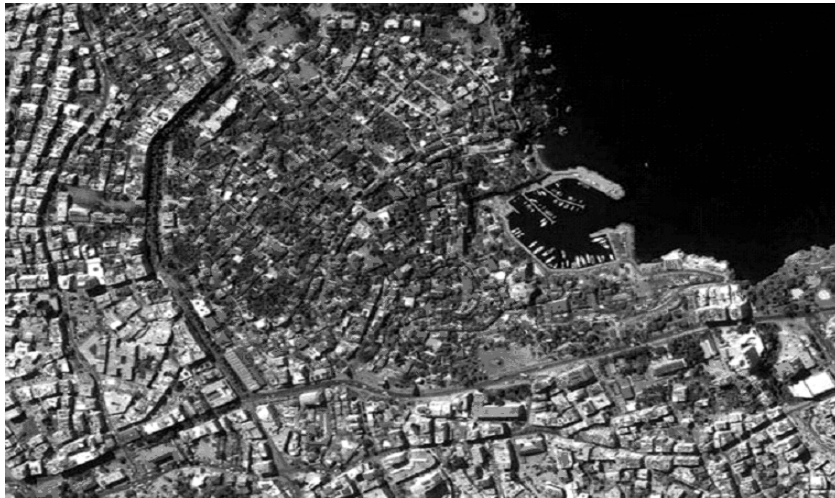
*Figure 2.* Antalya-Kaleiçi Region (Anonymous 2008b)

Antalya-Kaleiçi historical houses have conventional settlement characteristics in terms of being in harmony with the topography. The houses are appropriate for the land slope and built above the sea level since the city is at a hot-humid climate region. Most of the streets harmonious with the topography spread in the northwest- southeast direction which is the prevailing wind direction and since the houses are built in a way that they could make use of prevailing breeze as much as possible they are acceptable for ecological design criteria. Since the buildings are adjacent they have two fronts –northeast and southwest- and their front receiving the sun light is limited. Due to narrow streets, the buildings overshadow each other and the building surfaces do not warm up. The garden areas among the buildings are in the same direction with the wind so one can benefit from the wind inside the building thanks to the halls opening to the gardens. The trees appropriate for the climatic conditions of the region are used in order to provide shade and prevent the building fronts from warming up (Figure. 2) (Aktuna, 2007).

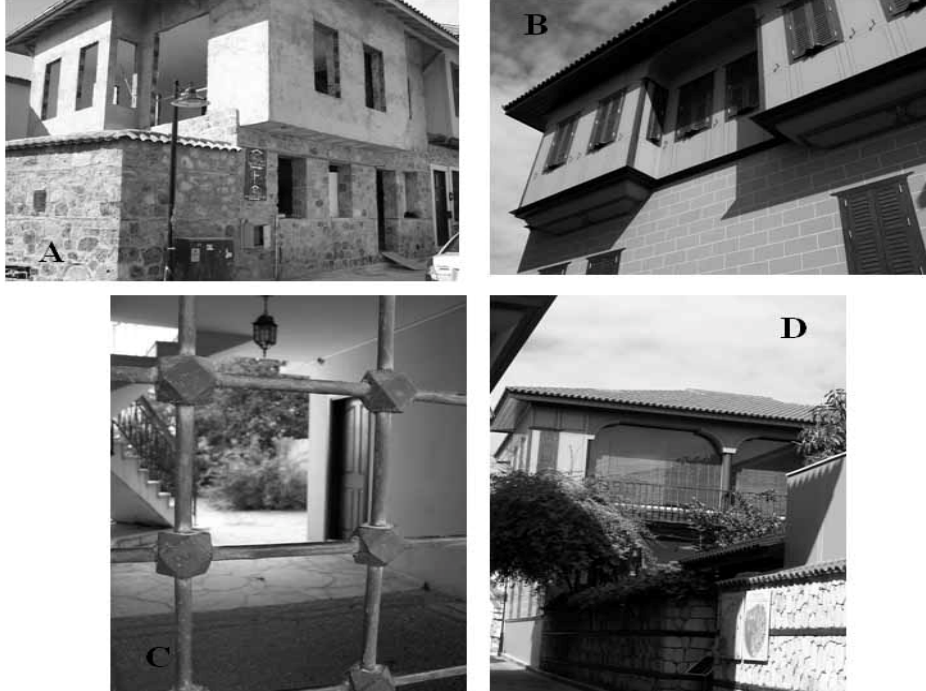
*Figure 3.* Samples from Antalya Kaleiçi (Original, 2009).

At the restoration stage, when the halls are converted into indoor places in order to have extra-room, this ruins the place organization and hinders the room from receiving wind (Figure 3-C). Not using the hall in accordance with its usage aim in the buildings which are mostly used for touristic purposes, changing floor covering materials, disabling traditional wells and pools or covering their upper sides are some of the problems faced during the restoration (Figure 3-D). New parts such as bathroom etc. which are added to have more room or added during function shift ruin the place organization.

The use of stone-covered walls or stone-like walls instead of real stone walls at the restored buildings doesn't let the building make use of the advantages provided by the stone walls (Figure 3-A,B). At the upper floors the timberwork system is commonly used in order for the building to breathe. Most of the time, the historical building is eradicated and rebuilt with the modern materials. The buildings restored with the unnatural materials lose their originality in terms of ecological material feature. When the floor coverings at the halls are covered with other materials, the porous floor coverings are destroyed and the floor coverings lose their refreshing feature (Figure 3-D).

In the restored buildings, some mistakes such as turning outer halls into indoor places using glass construction elements and creating extremely hot places with the greenhouse effect are observed. Going beyond the traditional building dimensions in terms of fringe sizes and wall heights or designing new buildings without balconies affect the rate at which the street or the building is becoming shaded. If the wood shutters are not renewed in accordance with their originals, this influences the air stream. And similarly if some of the windows are disabled, this blocks the air circulation inside the building.
